National Register of Historic Places
Registration Form

historic name Olive Hotel
other names/site number _____

street & number 501 Main Street not for publication
city, town Miles City vicinity
state Montana code 030 county Custer code 017 zip code 59301

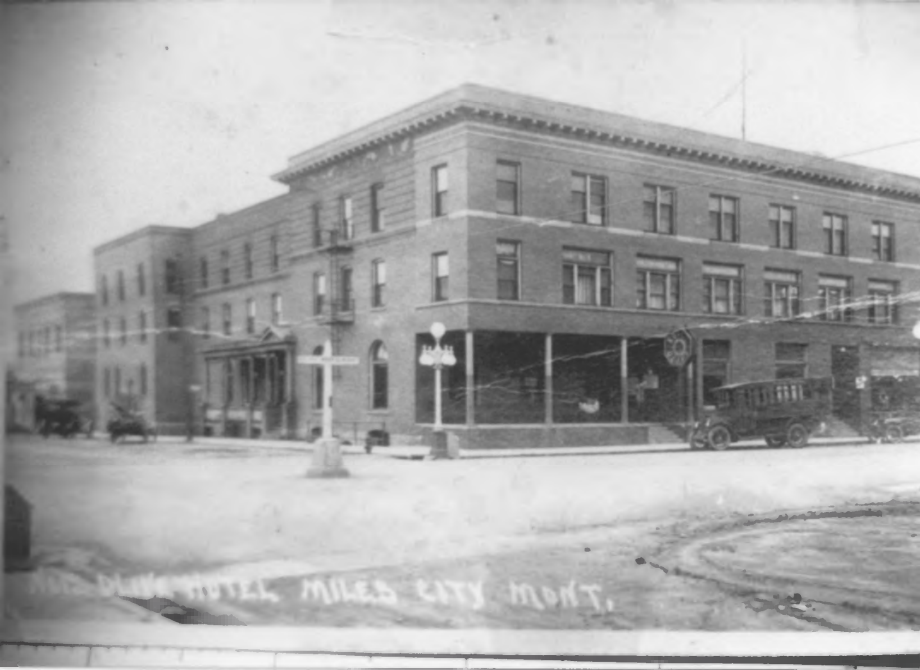
C-1-7

Views: looking northeast at south and west
elevations

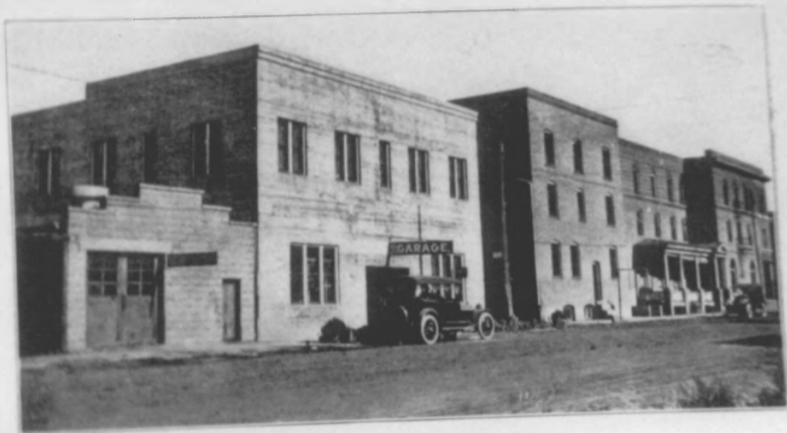
Olive Hotel and Garages C-8-9
501 Main Street, Miles City
Custer County, Montana

The Olive Garage and Repair Shops.

View: looking east at 5th street side of Olive Hotel
and auto garages.

The second garage to be built in association with the Olive Hotel is a two-story structure constructed ca. 1912 that was used as an "auto livery" as well as an automobile sales room and a repair shop. A second floor enclosed walkway over the alley connects this garage to the hotel building. This garage also was designed to be faced with a brick veneer. However, the veneer was never applied and the anchor strips still protrude from the south elevation facing the alley. The structure features one-over-one double hung windows set singly or in pairs, and a large garage opening centered at the street level of the facade. With the exception of the enclosure of the two first floor sets of three windows flanking the garage opening, this garage retains virtually complete historic architectural integrity.

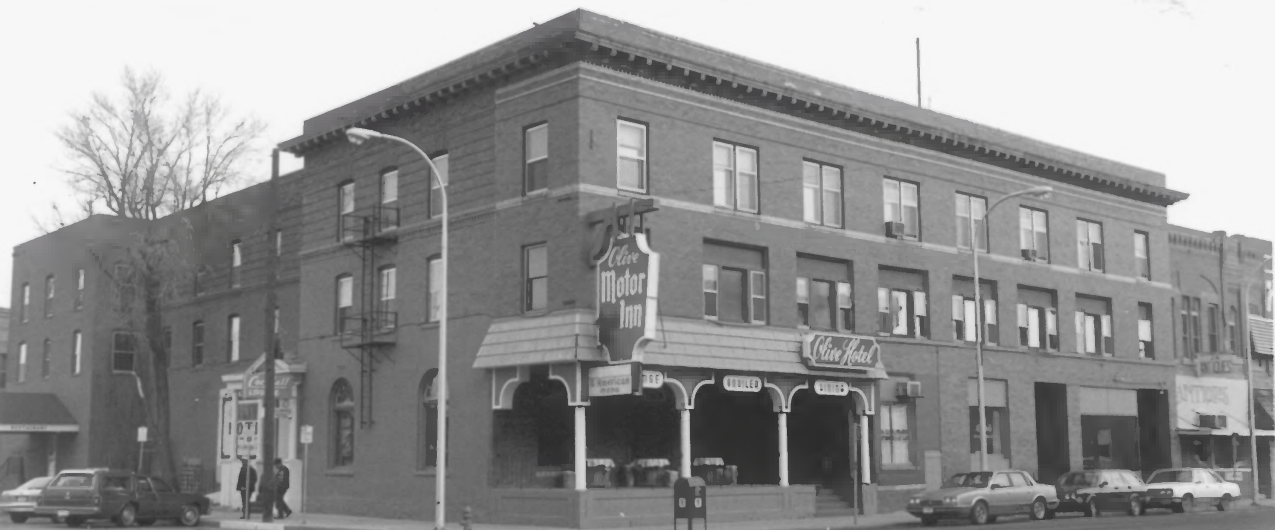
Olive Hotel

View: looking northeast at
south and west elevations

The front addition extended the building one bay to the south, and brought the front elevation to the lot line on Main Street. Designed by local architect Brynjulf Rivenes, this addition created an entirely new facade for the hotel and joins the 1890's portion to the 1908 east addition as a single composition. Windows are again one-over-one, double hung units, flanking large fixed windows with transoms above on the second story, and set in pairs on the third. Light yellow brick belt courses run at the third floor window sill level, are used to enliven the simple dentilated frieze beneath the bracketed, pressed metal cornice and appear as coping. The street level of the front facade is divided into three commercial spaces with two separate entrances and large, plate glass windows.

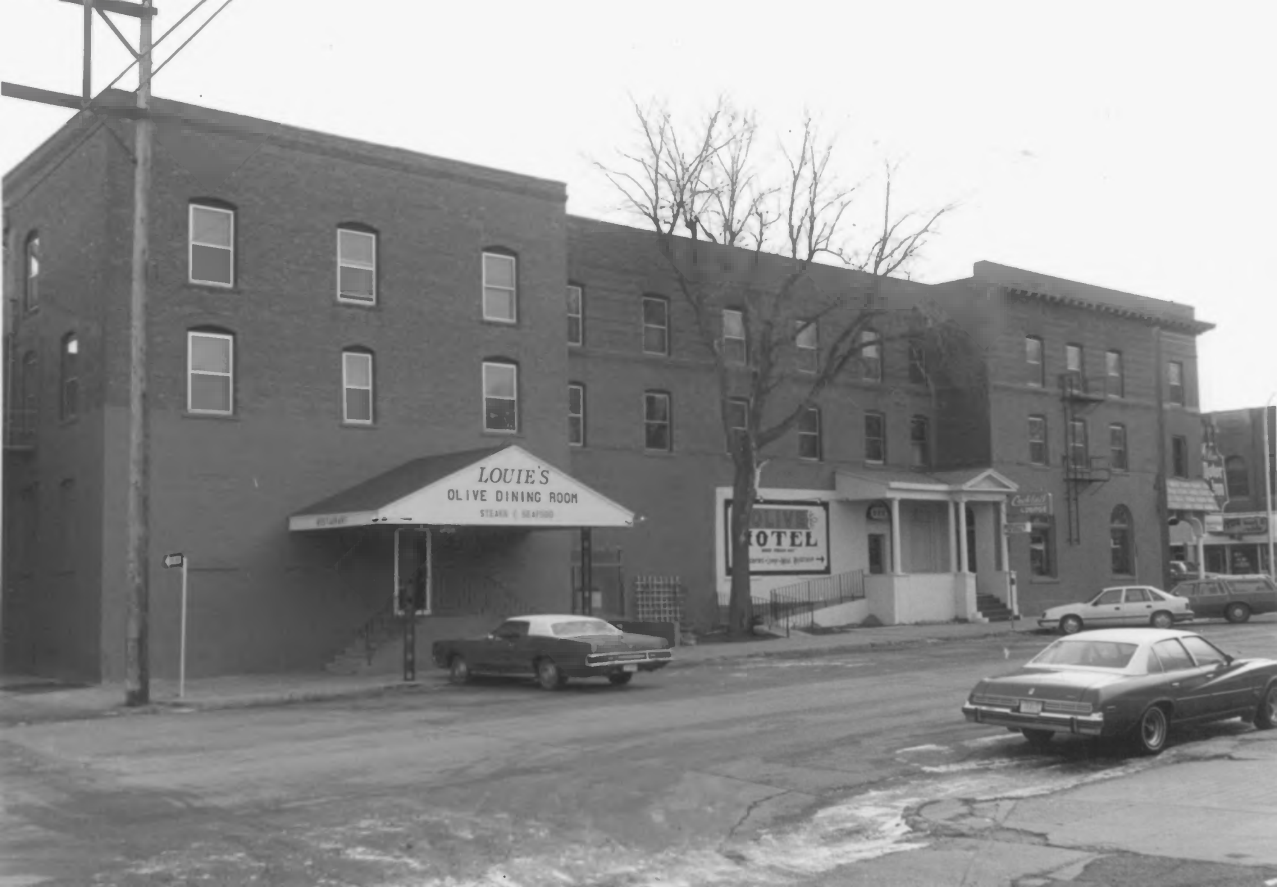
Olive Hotel

View: looking east at west elevation

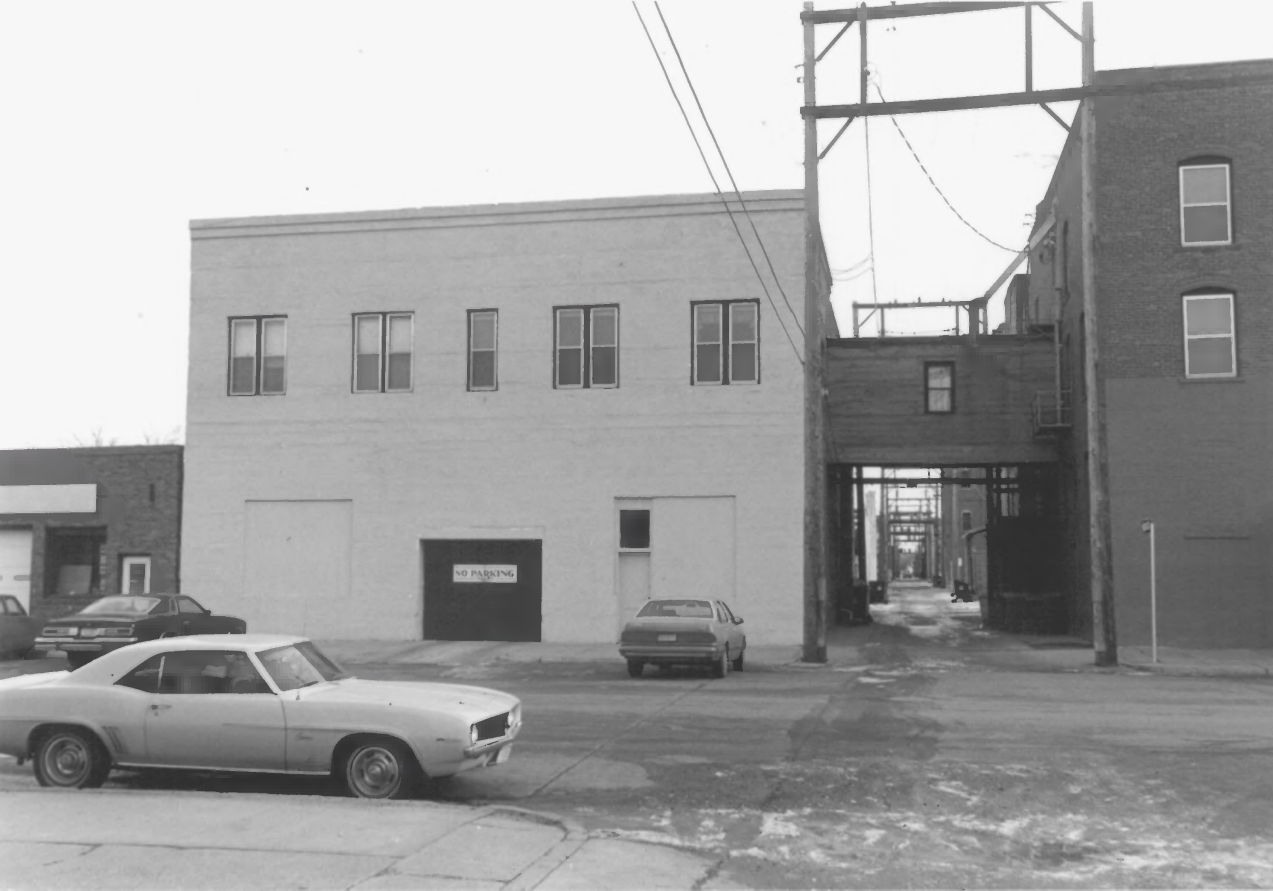
View: looking east at west

elevations of both auto

garages associated with Olive Hotel.

Two poured concrete garages are located to the rear of the hotel across the alley, and both structures contribute to the significance of the Olive Hotel. The earlier garage, built in 1908, is a one-story structure with a large opening cut into the facade, which was originally fitted with double wooden, 6-light doors, but now is closed with a modern, overhead, metal door. Brick veneer was applied to the facade of this garage, likely ca. 1920, and a single fixed window was added. The brickwork matches that of the 1908 Olive Hotel additions, and the new facade may have been designed by Rivenes.
